## TESTING / INSPECTION REPORT

REPORT NO : VT-150911-1

TEST / INSPECTION ITEMS : Vibration &amp; Shock Test

**Reference to EN50155/(EN)IEC 61373 , Category 1 , Class B****Shock test (Operating)**

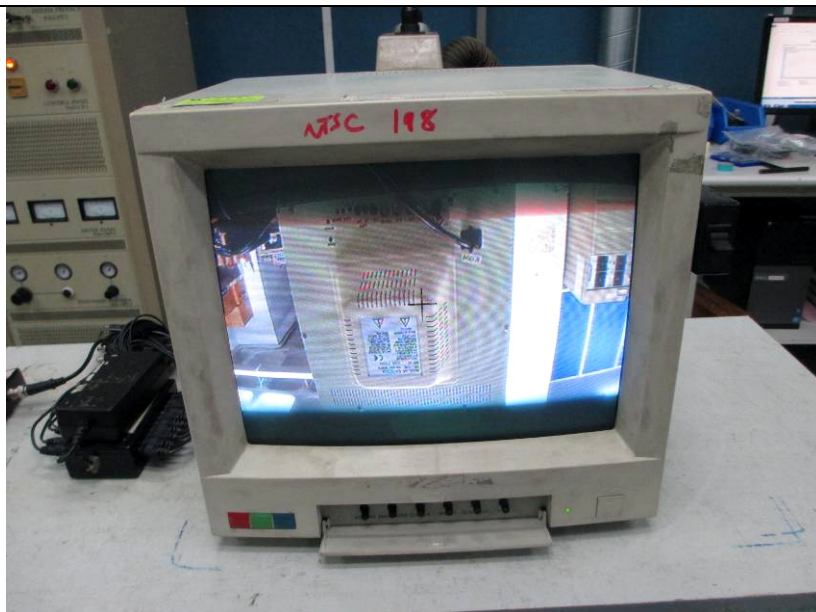
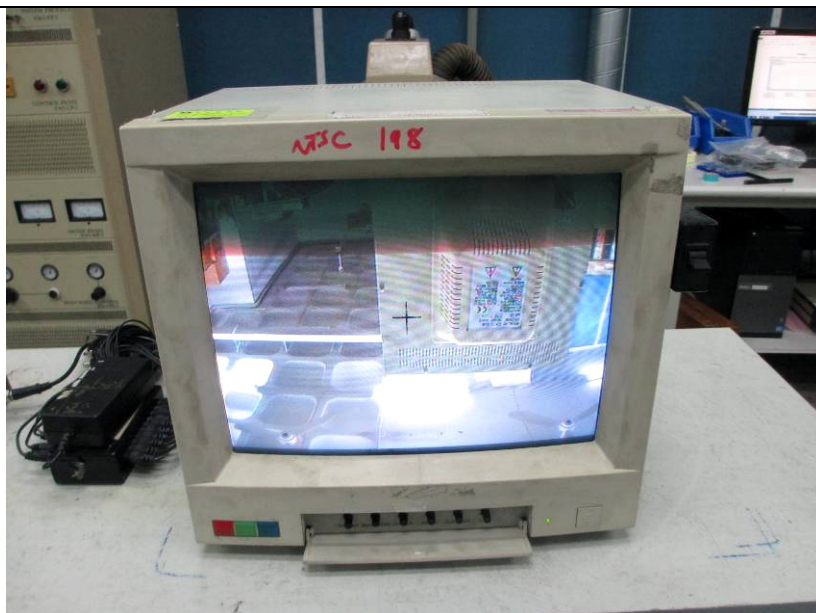
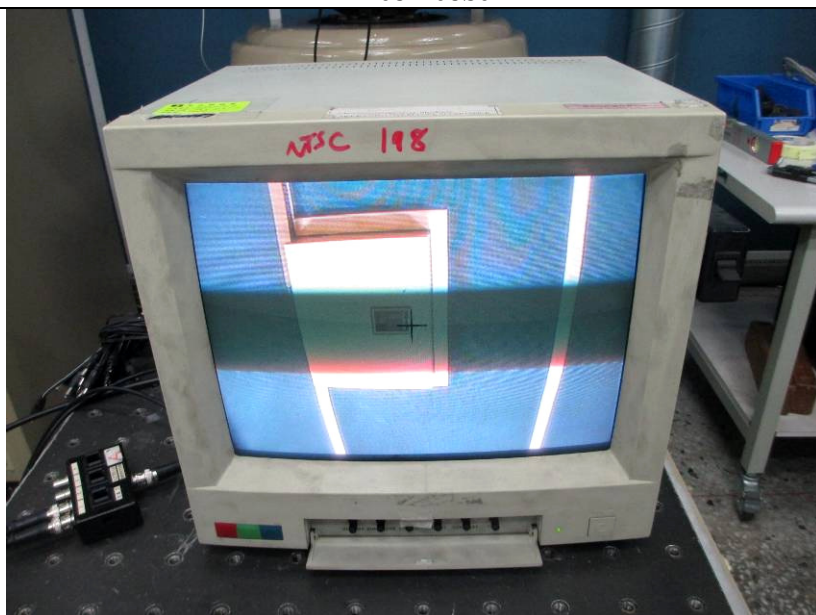
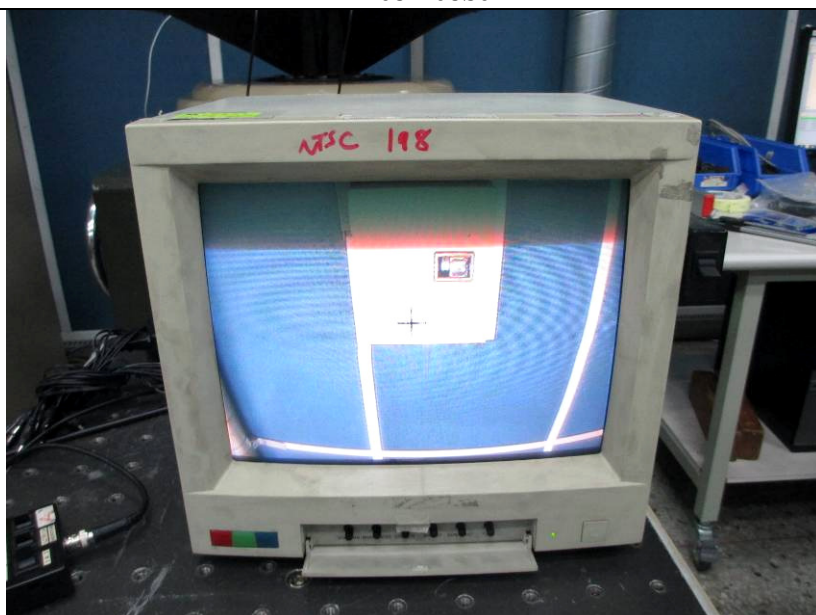
| Describe | PASS | FAIL | Non-Judgment |
|---|---|---|---|
| Appearance check | √ | — | — |

#### After test

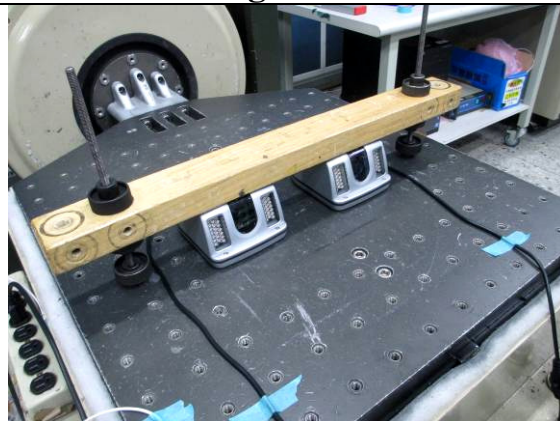
**Longitudinal**

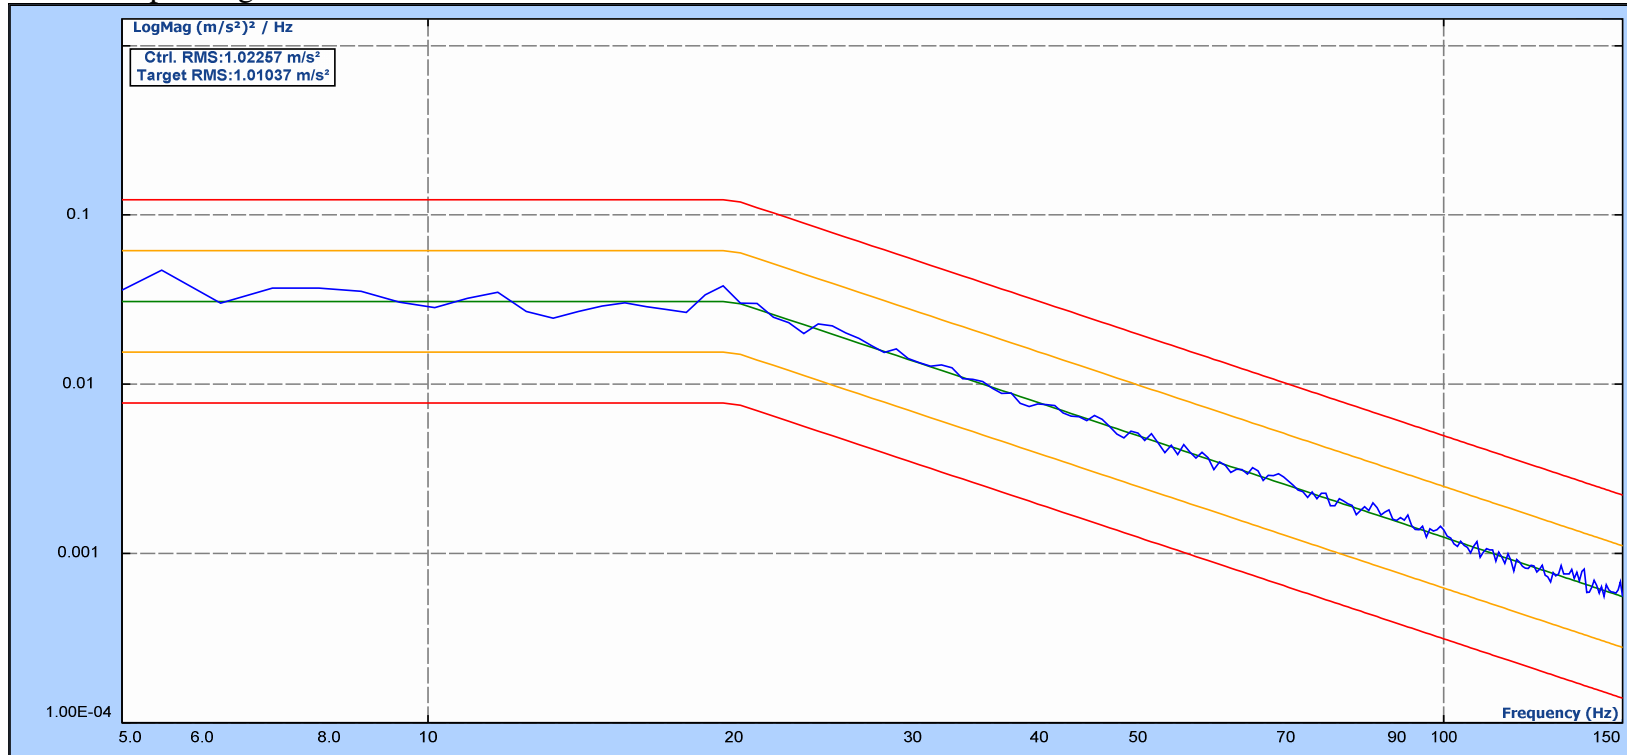
Vertical - operating

Control RMS: 1.023 m/s<sup>2</sup>

Est. Disp. : 1.820 mm Pk-Pk

Target RMS: 1.003 m/s<sup>2</sup>

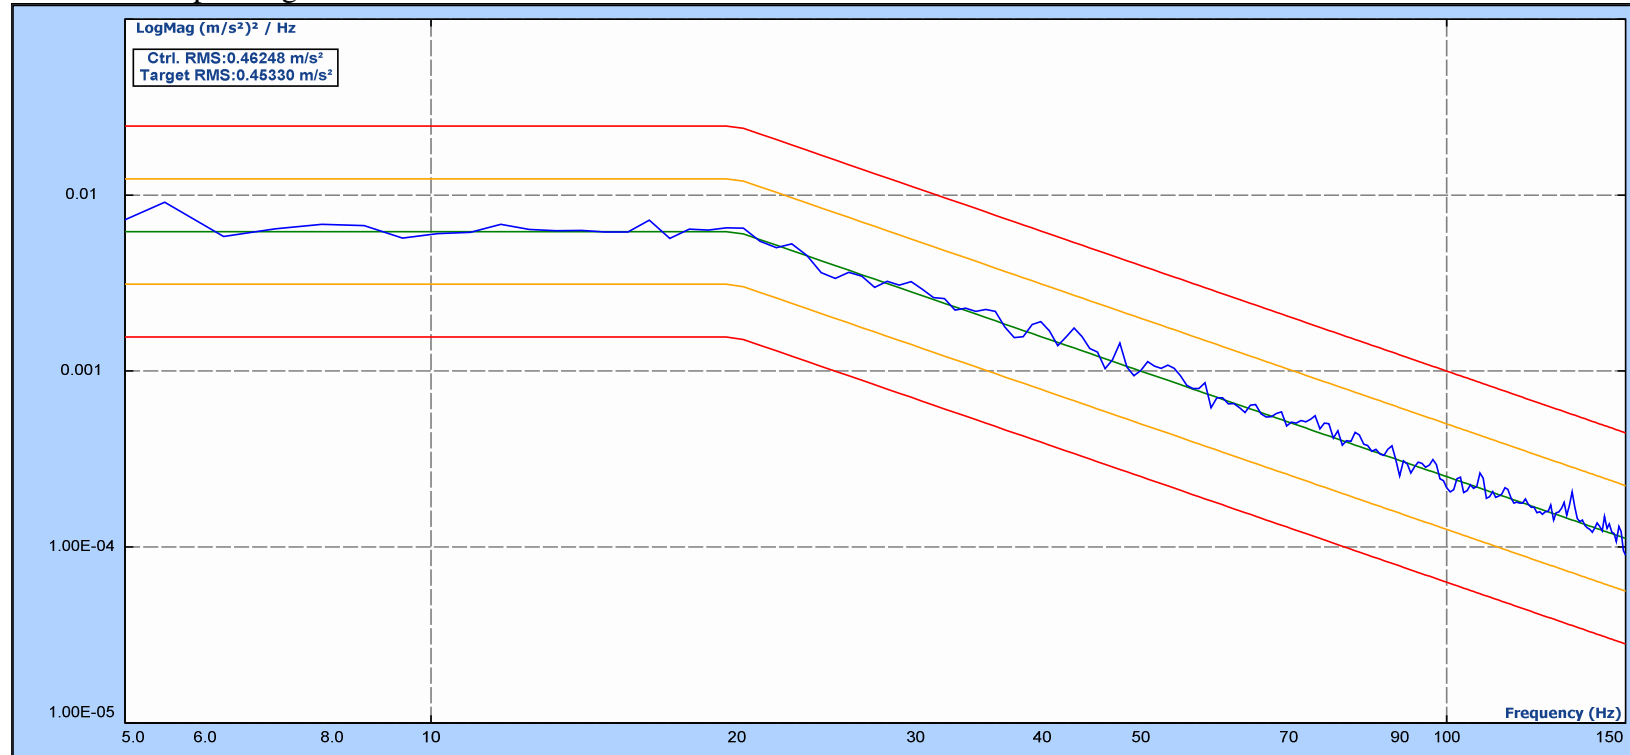
## Transverse - operating

Control RMS: 0.462 m/s<sup>2</sup>

Est. Disp. : 0.810 mm Pk-Pk

Target RMS: 0.450 m/s<sup>2</sup>

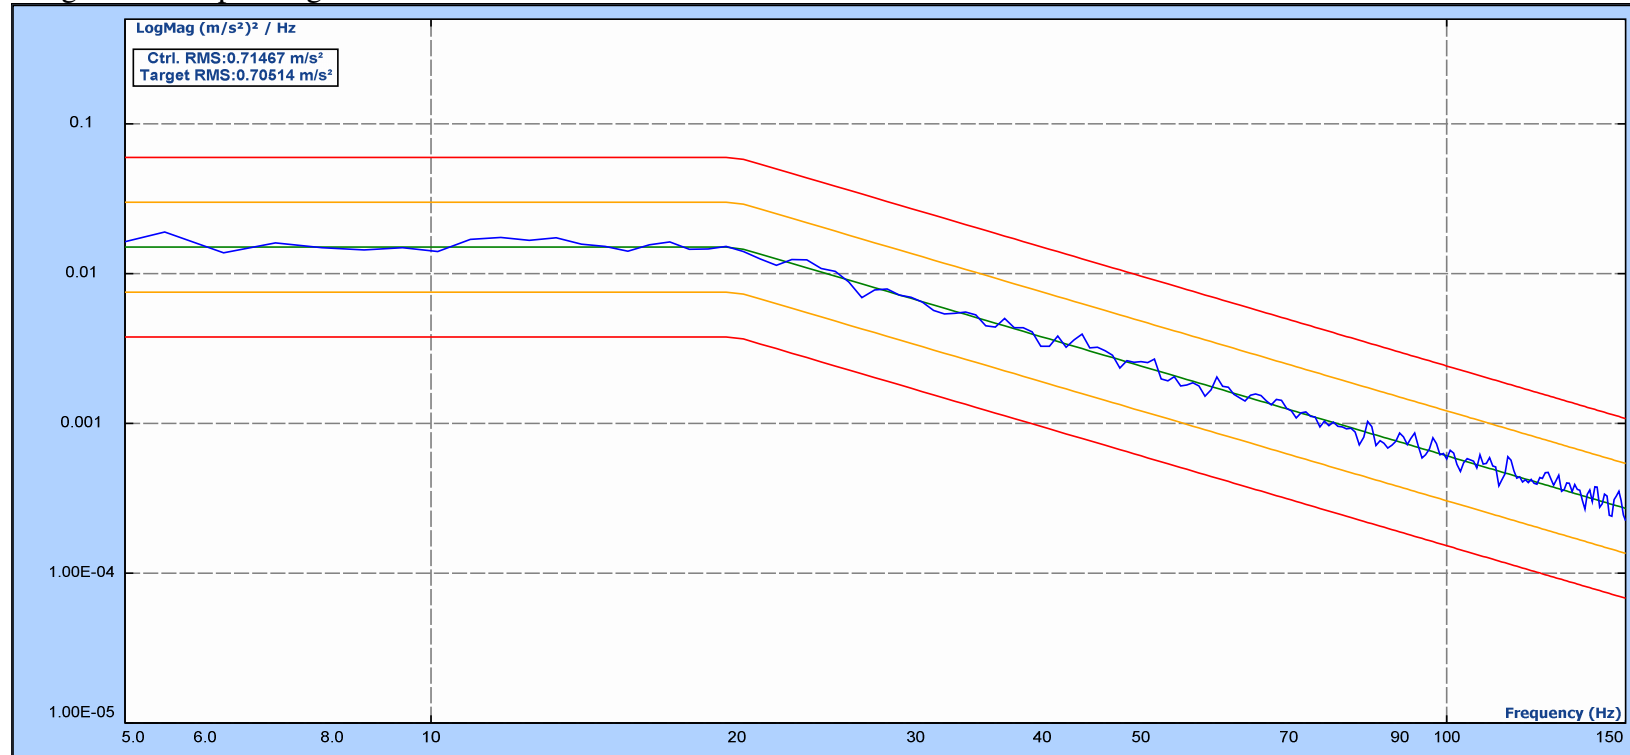
## Longitudinal - operating

Control RMS: 0.715 m/s<sup>2</sup>

Est. Disp. : 1.227 mm Pk-Pk

Target RMS: 0.700 m/s<sup>2</sup>
